CITY OF HAMILTON

WATER POLLUTION SURVEY OF SEWER OUTFALLS
AND TRIBUTARY STREAMS TO HAMILTON BAY

DISTRICT ENGINEERS BRANCH

1967

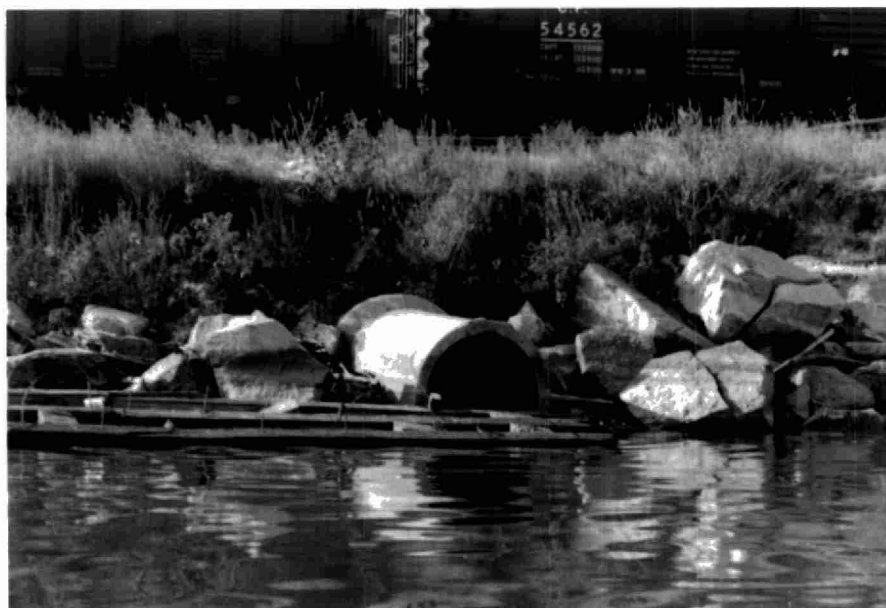
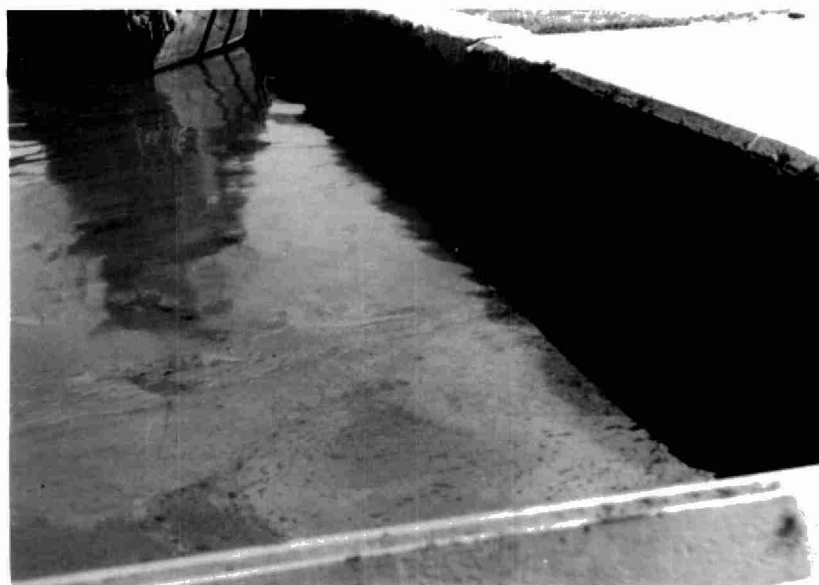
TYPICAL STORM SEWER OUTFALLS

THESE TWO PICTURES SHOW PARTIALLY SUBMERGED STORM OUTFALL SEWER TYPIFYING THE TYPES DISCHARGING TO HAMILTON BAY. DIFFICULTIES IN FLOW MEASUREMENT ARE OBVIOUS.

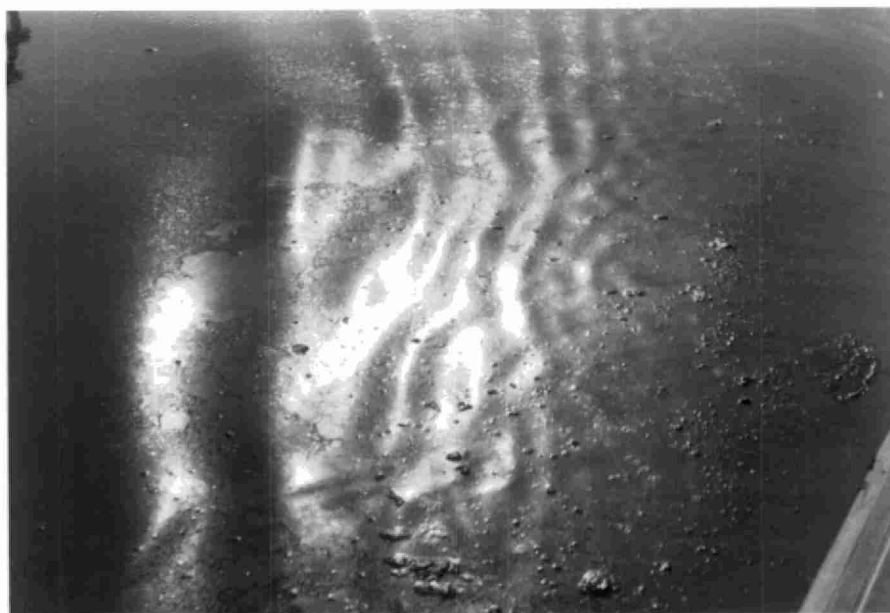
UNIDENTIFIED SLIP AT EAST END OF PAD-200

WATER COATED WITH BLACK OIL AND FAECAL SOLIDS. A TYPICAL
OBSERVATION IN EAST END BOAT SLIPS.

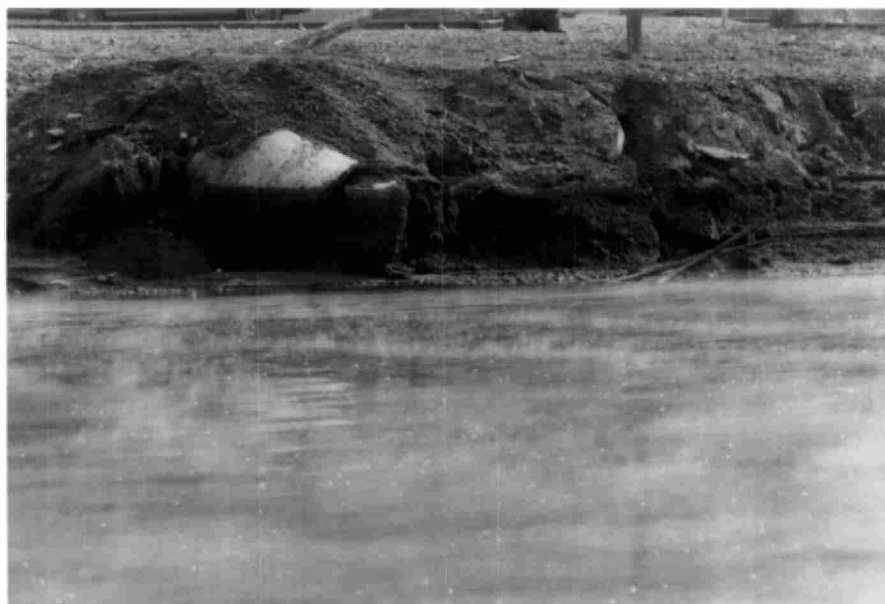
EAST END SHORELINE

OIL ACCUMULATIONS SHOWN ALONG SHORELINE, BUBBLES AND
FOUL ODOURS INDICATE SEPTIC CONDITIONS. THERMAL EFFECTS
OF INDUSTRIAL DISCHARGE CREATE STEAM ON SURFACE.

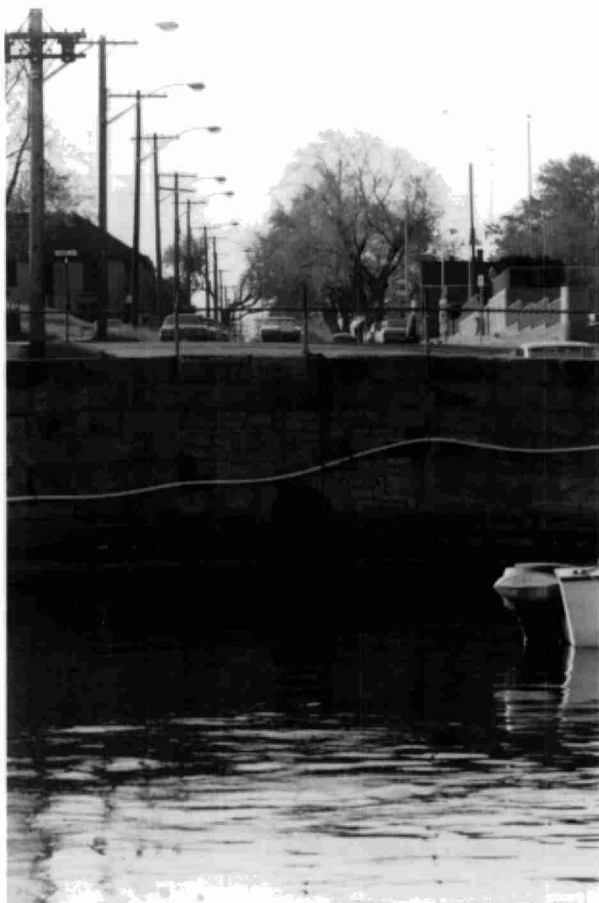
JAMES ST. STORM OUTFALL

INDUSTRIAL AND DOMESTIC
WASTES PRESENT WITH FLOAT-
ING FAECAL MATTER IN EVIDENCE.

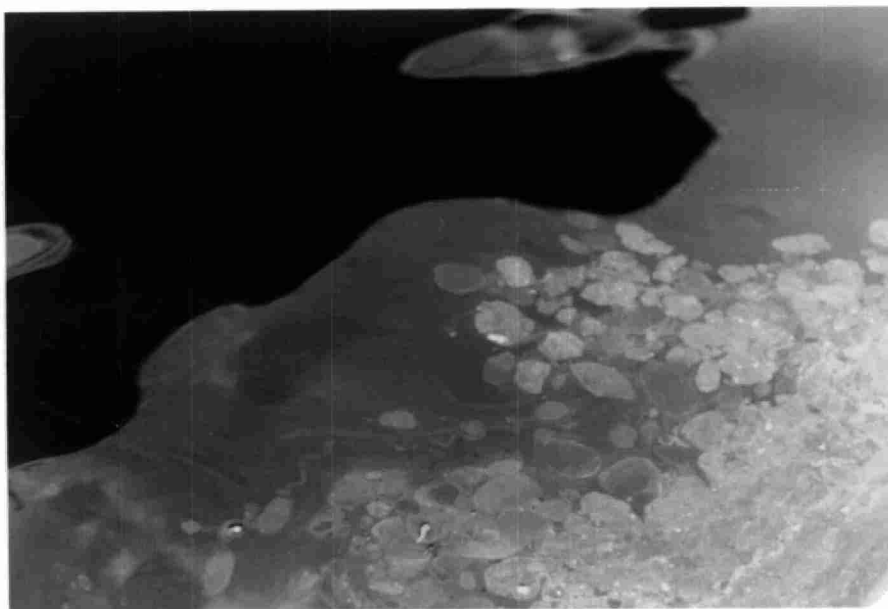
JAMES STREET SLIP

PICTURE SHOWS OIL ON WATER SURFACE AND SMALL
AMOUNTS OF FLOATING HUMAN EXCREMENT.

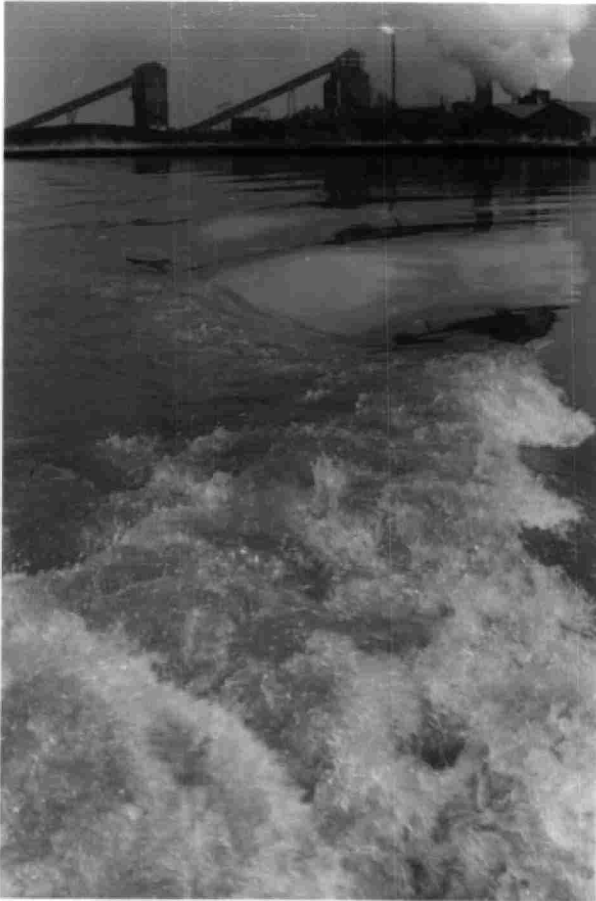
HAMILTON RAY NEAR OTTAWA ST.

WATER WAS DISCOLOURED YELLOW-BROWN. FLOATING OIL ALSO WAS PRESENT.

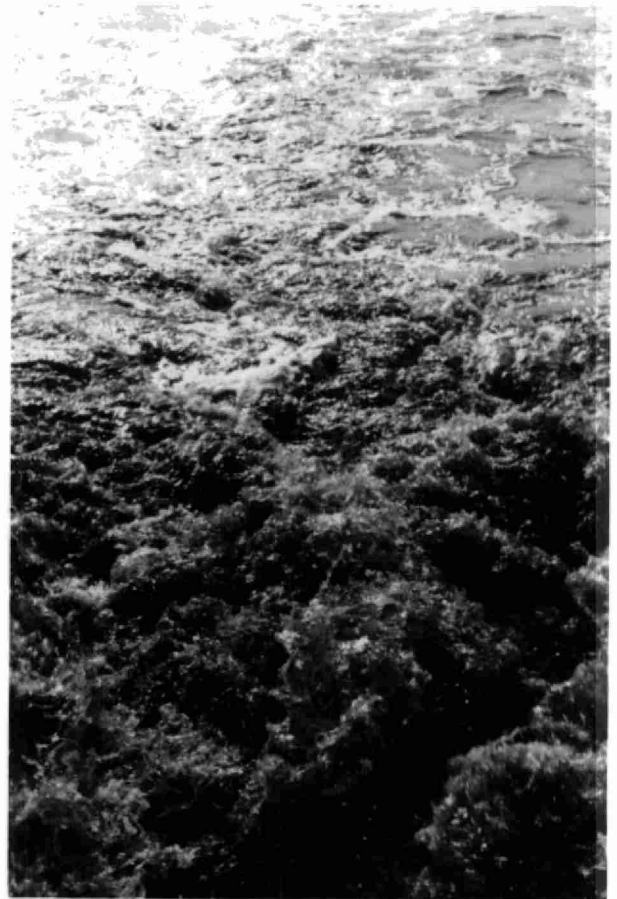
OTTAWA STREET SLIP

EXTENSIVE DEPOSITS
OF BLACK OIL AND
SEPTIC SLUDGE WERE
STIRRED UP IN WAKE
OF BOAT.

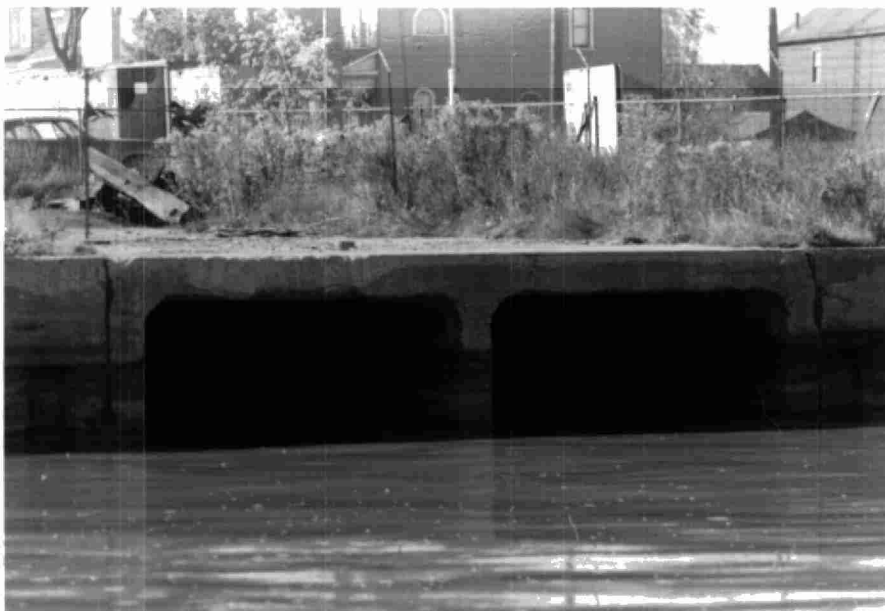
WELLINGTON ST. STORM OUTFALL

EXTREMELY LARGE AMOUNTS OF DOMESTIC AND INDUSTRIAL POLLUTION ENTER HAMILTON BAY FROM THIS SOURCE. THE RECEIVING WATERS HAVE BECOME SEVERELY CONTAMINATED AND A GREAT DEAL OF HUMAN EXCREMENT WAS VISIBLE.

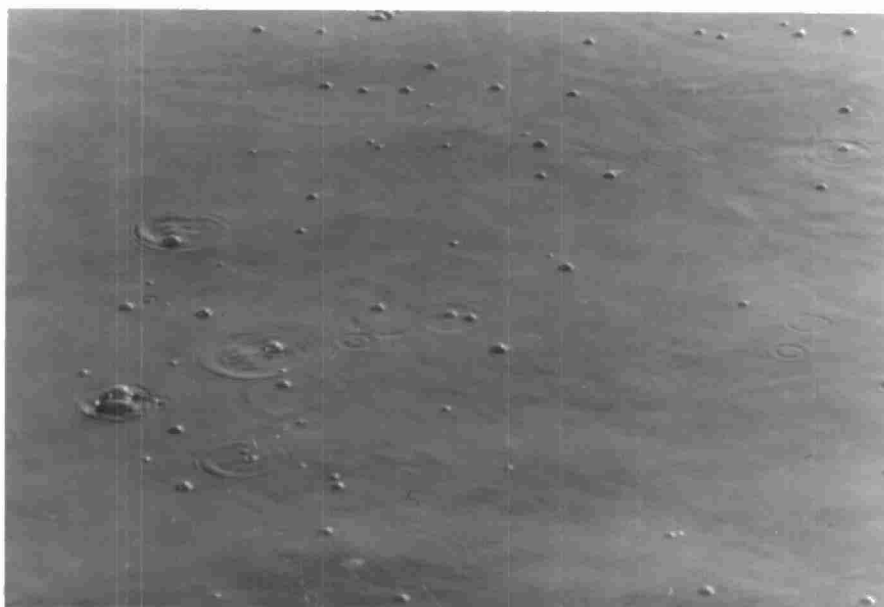
WELLINGTON ST. SLIP

IN THIS CLOSE-UP OF THE WATER SURFACE, FLOATING SOLIDS ARE VISIBLE. BUBBLES OF SOUR GAS CAN BE SEEN RISING FROM THE ACCUMULATIONS OF SEPTIC SLUDGE ON THE BOTTOM OF THE SLIP.

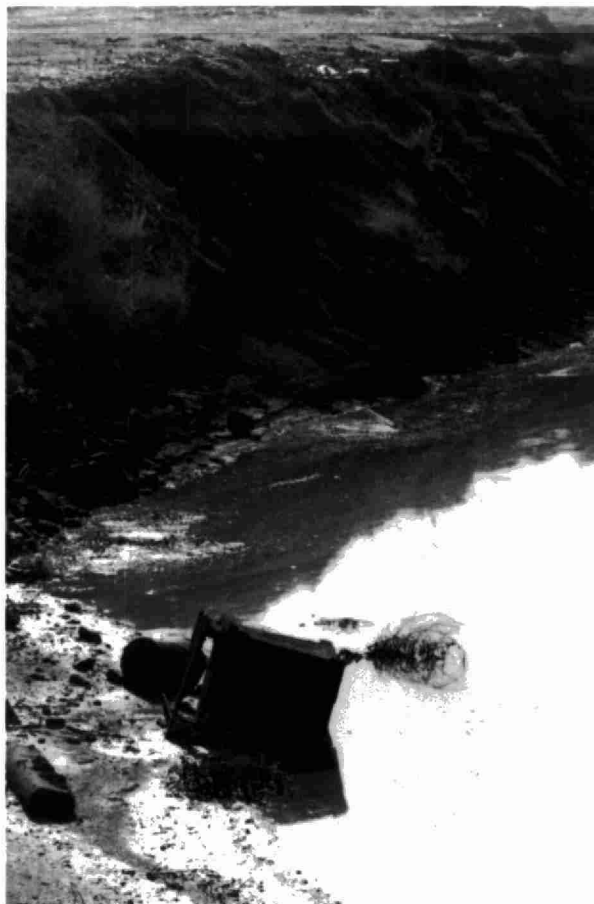
BOTTOM OF BIRCH AVE.

SHORELINE OF SHERMAN INLET SHOWING
FLOATING OIL AND DEBRIS. OILY
SLUDGE HAS ACCUMULATED AT THE BASE
OF THE EMBANKMENT.

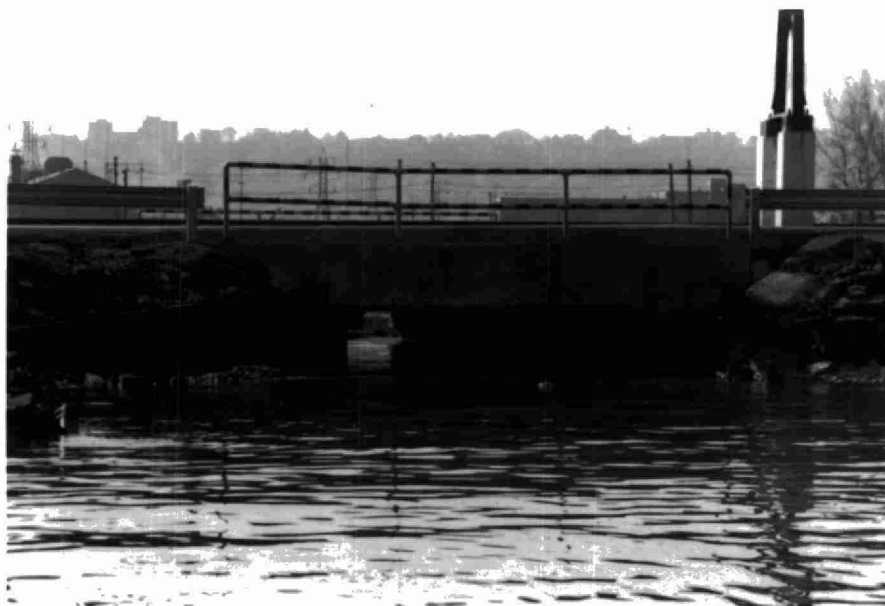
BIRCH AVENUE SLIP

OIL AND FAECAL SOLIDS WERE FLOATING ON THE
WATER. EXTENSIVE SANITARY AND INDUSTRIAL
POLLUTION WERE IN EVIDENCE.

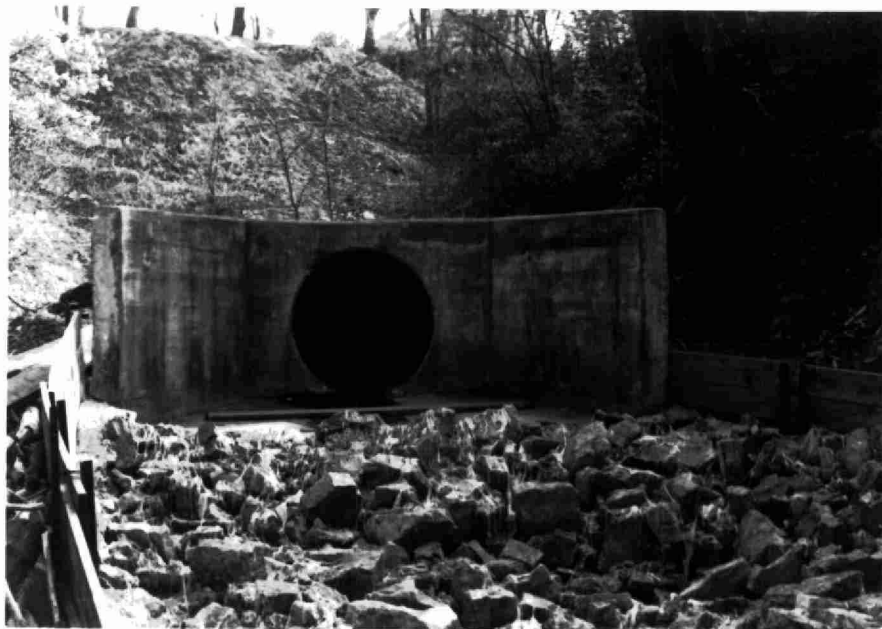
STERLING ST. NEAR FORSYTHE AVENUE

STORM SEWER DISCHARGE INTO CREEK BED SHOWING THE REMAINS
OF HUMAN EXCREMENT AND TOILET TISSUE.

The Sterling Street storm sewer (no.32), although not flowing during the inspection, showed visual evidence of a recent sanitary sewage discharge into a local ravine. The drain outlet to Ancaster Creek (no.53) at Highway 8 showed a high 5-day BOD and the presence of phenols indicating pollution of industrial or domestic source. It is understood that the Main Street sewer has an overflow weir at Ewen Road with an outfall into Ancaster Creek below West Park Avenue (no.31). At the time of inspection, during relatively dry weather, although the Main Street sewer was not by-passing, it was flowing almost full indicating that by-passing would probably take place quite frequently with any amount of rainfall.

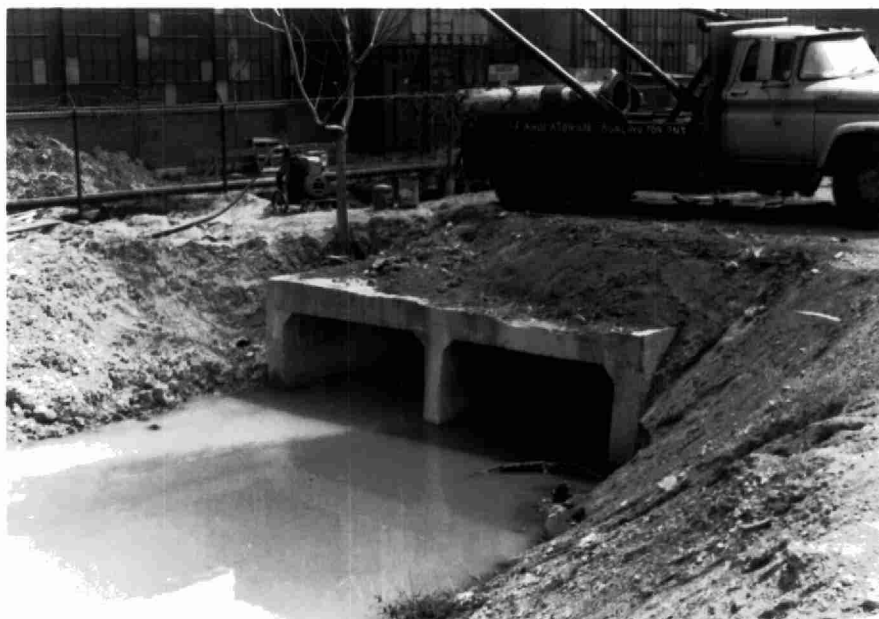
KENILWORTH AVENUE STORM OUTFALL

DISCOLOURATION AND FAECAL SOLIDS PRESENT. SLIP SHOWS
EVIDENCE OF EXTREME DOMESTIC AND INDUSTRIAL POLLUTION.
GAS BUBBLES AND FOUL ODOURS WERE INTENSE.

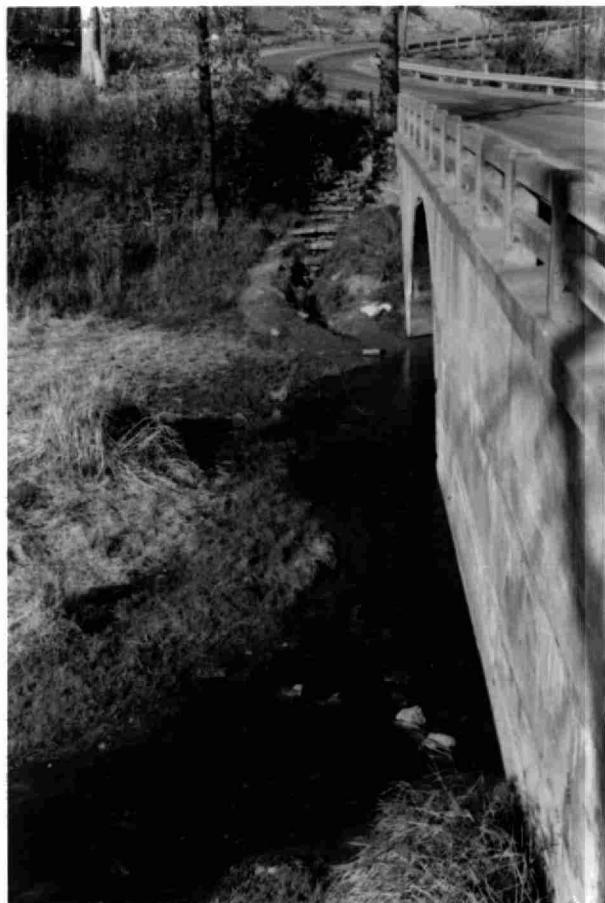
REDHILL CREEK AT ALBION
ROAD BRIDGE

ALGAE AND STREAM DIS-
COLOURATION IN EVIDENCE.

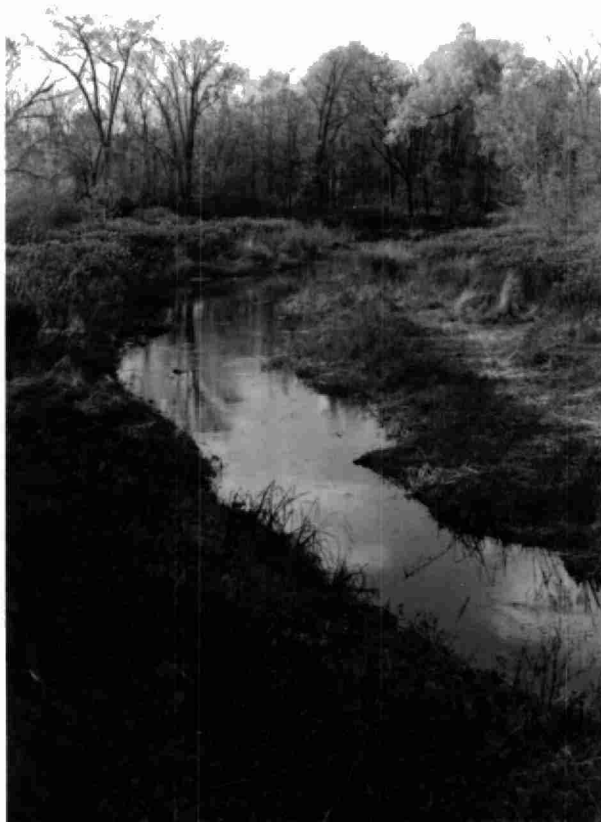
REDHILL CREEK WEST OF ALBION
ROAD BRIDGE

LOCATED DOWNSTREAM FROM UPPER
OTTAWA REFUSE SITE WITH DIS-
COLOURATION OF STREAM BANKS
NEAR WATER SURFACE CAUSED
BY LEACHATE.

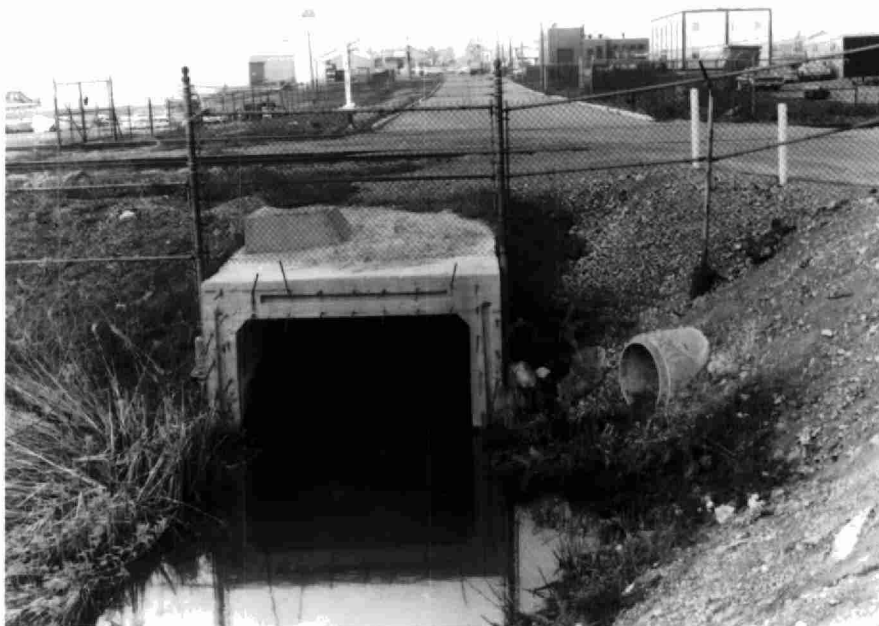
PARKDALE AVE. STORM OUTFALL

TYPICAL PARTIALLY SUBMERGED OUTFALL. BLACK OIL
AND FAECAL WASTES PRESENT ALONG EDGES OF DITCH.

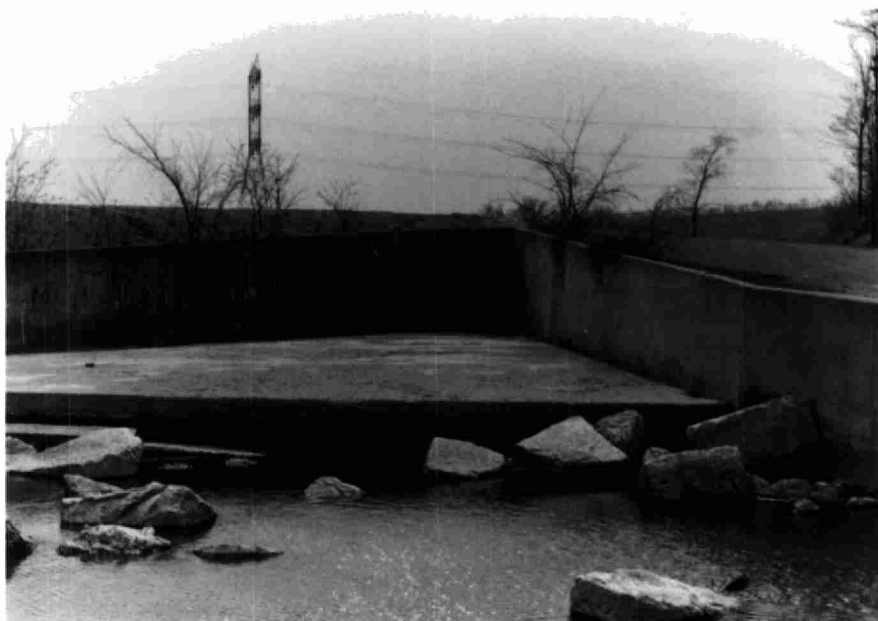
FOOT OF GREENHILL AVENUE

SEWER BY-PASS TO REDHILL CREEK AT ALBION PARK WHICH
PERIODICALLY DISCHARGES SANITARY WASTES.
